# Manhole Inspection Summary

Manhole # S15A\_\_005MH

Insp Date: **7/2/08 4:54 PM**

**Location** Address: **730 ASHBURTON**

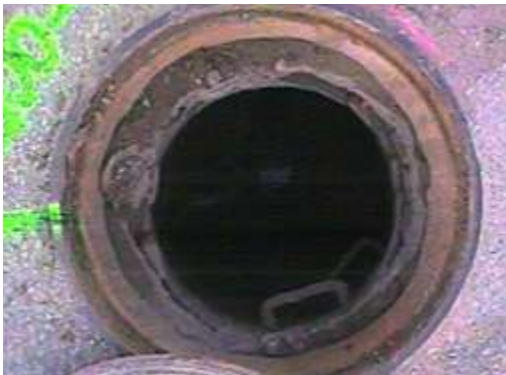
Defect 5

**Frame** Offset: **4** (in.) Condition: ☒ Sound ☐ Cracked ☐ Leaks

Frame offset

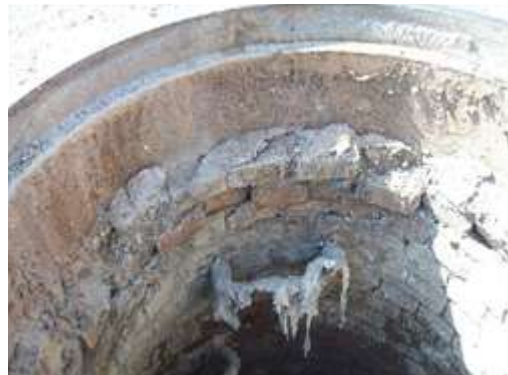
Defect 4

Condition: ☐ Sound ☐ Cracked ☐ Root Intrusion ☐ Loose Brick ☒ **Deteriorated**

**Surcharge** ☒ **Evidence Of Surcharge** Depth: **2** (ft.) ☐ Active Surcharge Present

Evidence of surcharge and barrel deterioration

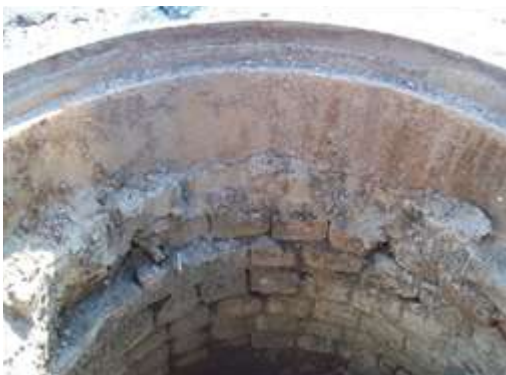
Defect 3

Condition: ☐ Sound ☐ Cracked ☐ Root Intrusion ☐ Loose Brick ☒ **Deteriorated**

corbel deterioration

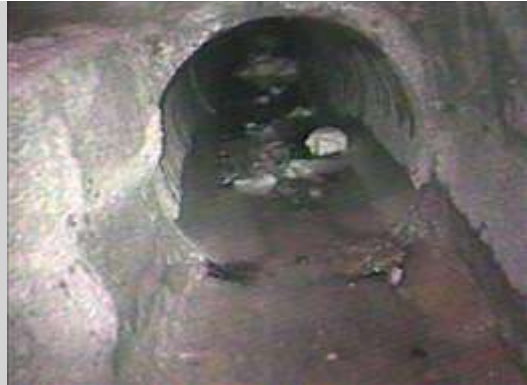
12 O'Clock Outflow

8 in. Circular Gravity Sewer  
Pipe Out @ 12 O'Clock

Pipe Material: **Clay** ☐ Pipe Lined

Invert Depth: **8.18** (ft.) Flow Characteristics: **Slow**

Infiltration: **None** Pipe Seal Cond: **Sound**

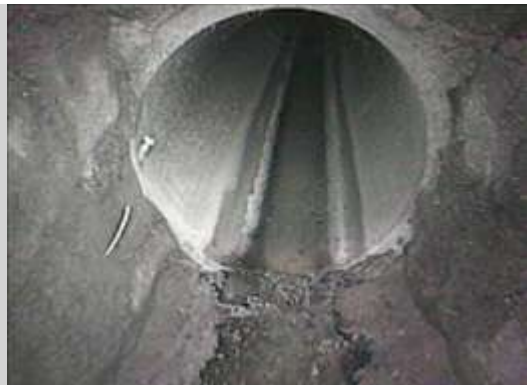
9 O'Clock Inflow

8 in. Circular Gravity Sewer  
Pipe In @ 9 O'Clock

Pipe Material: **Clay** ☐ Pipe Lined

Invert Depth: **7.95** (ft.) Flow Characteristics: **Slow**

Infiltration: **None** Pipe Seal Cond: **Sound**
